WHITE PAPER

Service Life Assessment of Low-Slope Unpainted 55%Al-Zn Alloy-Coated Steel Standing Seam Metal Roof Systems

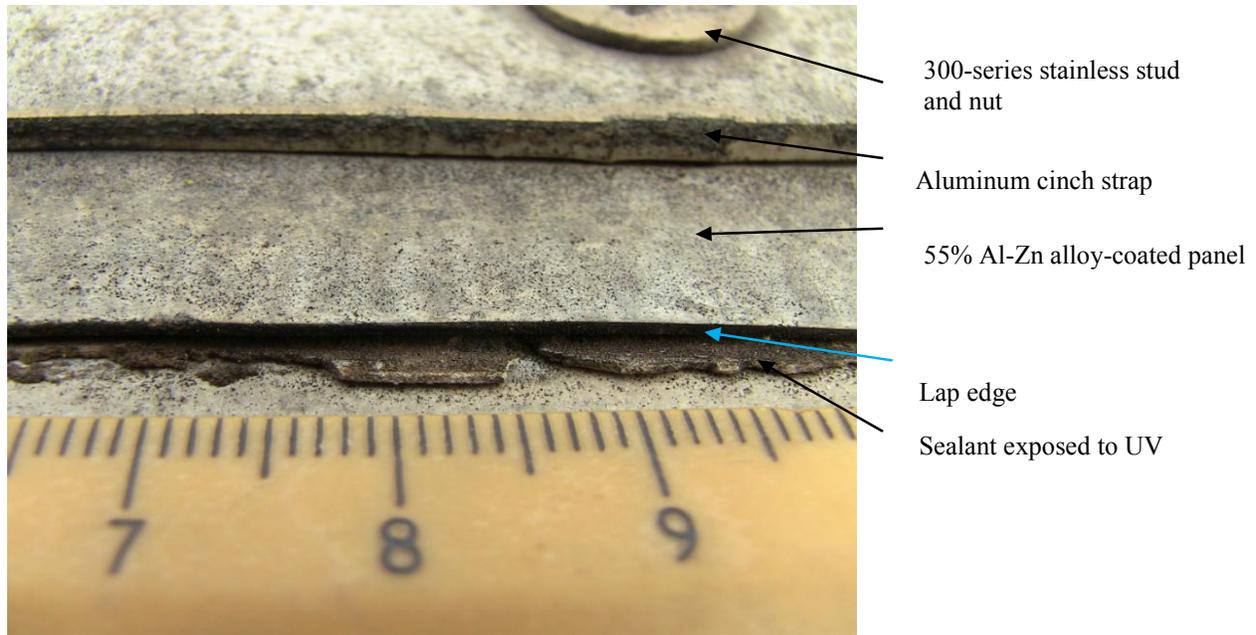
Edges and bends typically exhibit the first signs of corrosion as they are areas where a raw steel edge is exposed or where there may be a condition of tensile strain on the panel profile bend radius. Our inspections revealed excellent-to-very good performance in these two areas. The close-up photograph in Figure 10 shows a representative condition of a sheared, panel lap edge on the roof in Athens, GA. The sheared edge is free of red rust, indicating excellent long-term edge protection after 29 years. This performance is consistent with prior work [21] that reported only superficial stain and no rust deposits on exposure panels after 30 years of exposure in rural, industrial and moderate marine environments.

Figure 10 – Sheared, lap edge of 55% Al-Zn alloy-coated SSR panel showing negligible corrosion after 29 years on a roof in Athens, GA.

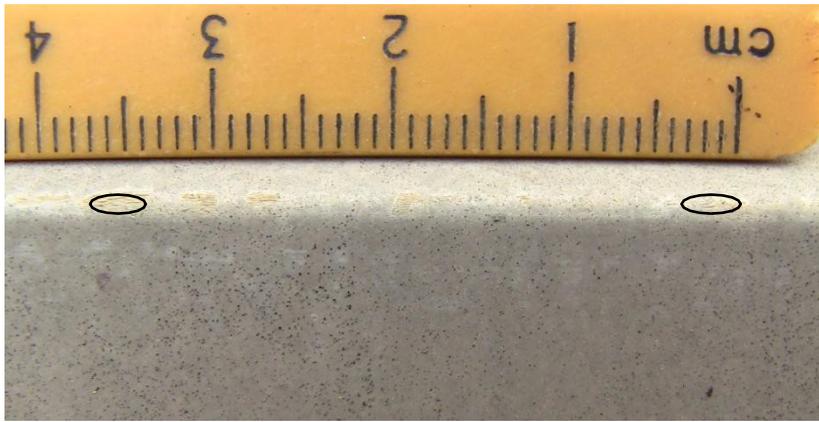
The photograph in Figure 11 shows a representative condition of the major rib profile radius of the SSR panel. Only minor crazing and light superficial staining is observable. The performance along the top radius of the standing seam is also excellent, as shown in a representative seam in Figure 12.

Figure 11 – Light crazing and superficial staining along a major rib profile radius after 29 years’ exposure on a roof in Athens, GA.

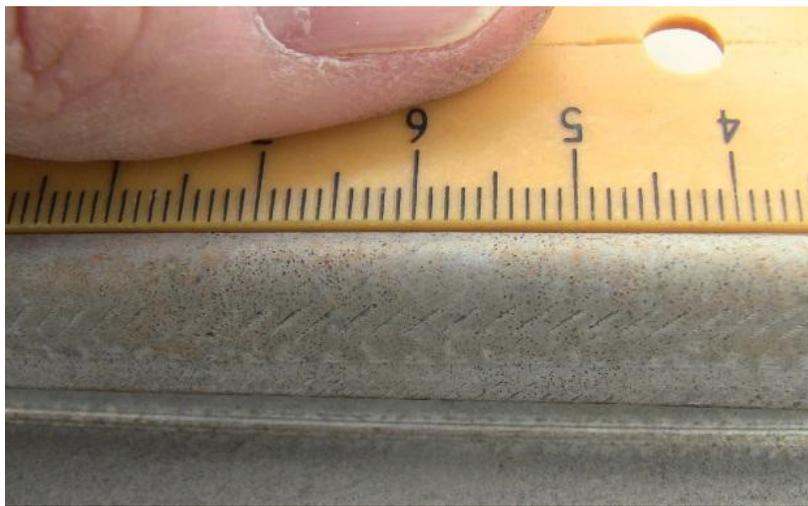
Figure 12 – Excellent performance (only brownish dirt pick-up) along the top radius of a standing seam on a 29-year old roof in Athens, GA.

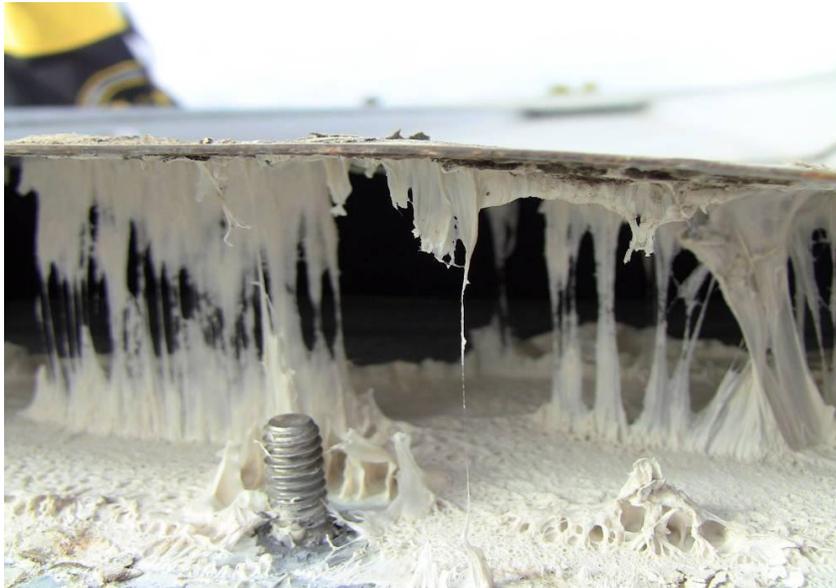
The butyl sealants used in the construction of these roofs were observed to be consistently tacky to the touch with good elastic webbing characteristics and adhesion to adjacent surfaces. A representative example of this performance is seen in Figure 13 which shows the disassembly of a 33-year old endlap.

Figure 13 - Excellent elasticity demonstrated by the butyl sealant on the Denver roof after 33 years.

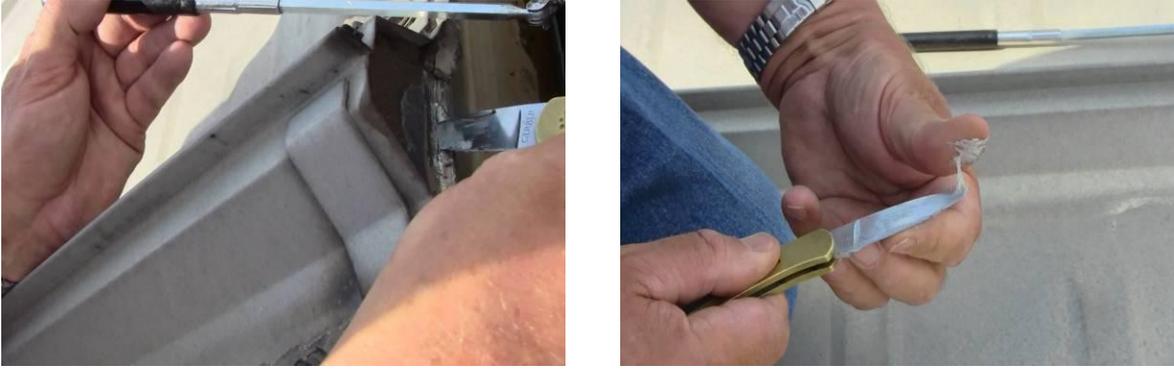
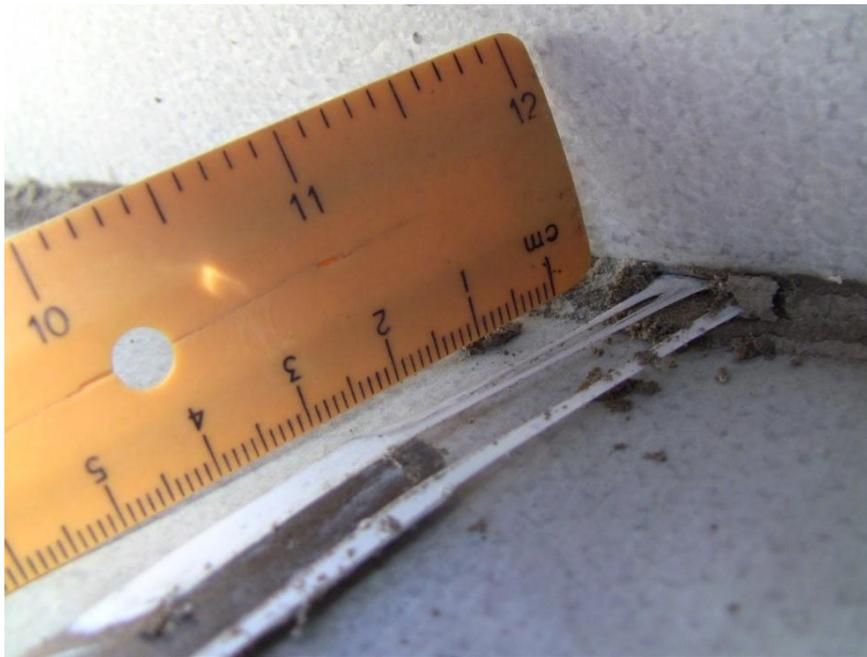
The butyl sealants at ridge and eave closures exhibited excellent elasticity and webbing characteristics. Figures 14 and 15 show the condition of the butyl sealant when the eave closure and ridge closure were probed with a knife edge. At fillets exposed to U.V. from the sun, the sealant was dry and chalky, forming somewhat of a barrier to further penetration of the elements into the lap. However, when the outer-most exposed material was removed, the sealant beneath and beyond exhibited the same tackiness, feel and elasticity as the endlap sealant sample area.

Figure 14 – Eave closure probed with knife edge (left) produced a sample of the butyl sealant that exhibited

significant elasticity after 33 years in Denver (right)

Figure 15 – Sealant between metal panel and metal ridge closure was also very elastic after 31 years in Wyoming.

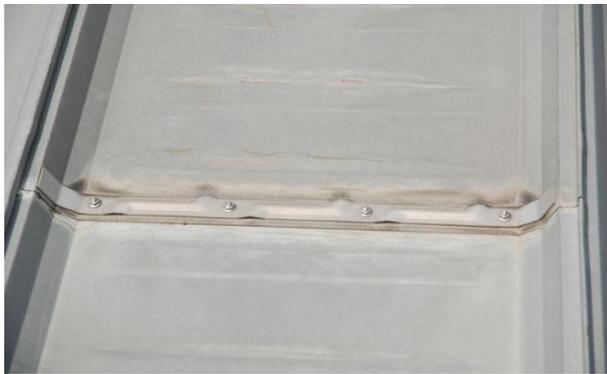
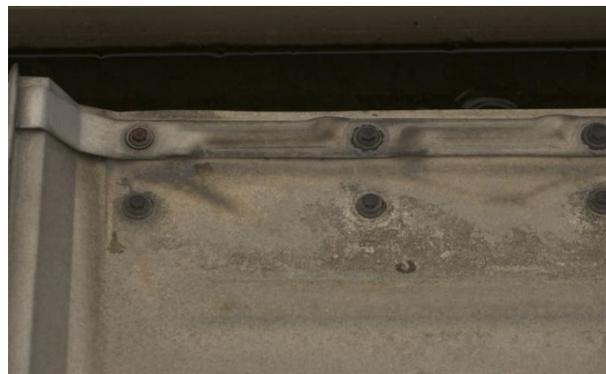
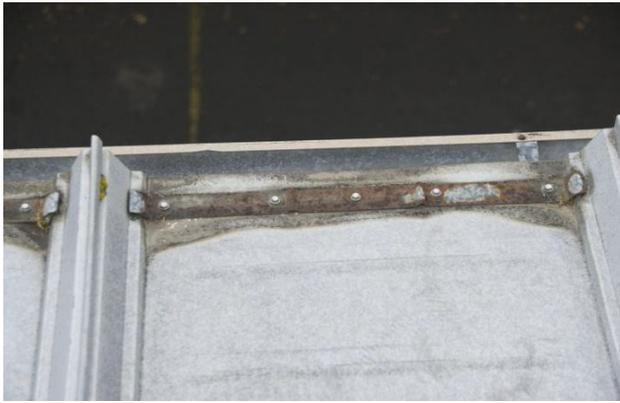
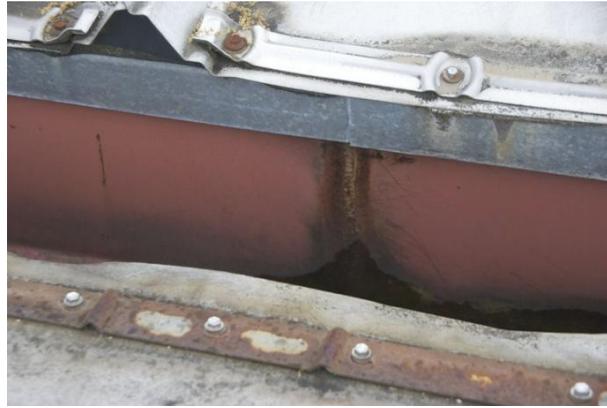
Figure 18 – Typical fastener appearance of various materials

Screw fastener types and materials encountered included Series 300 stainless steel, Series 400 stainless steel, carbon steel with Series 300 stainless steel cap, and carbon steel with (unidentified) plating or coating, examples of which are shown in Figure 18. In all cases, the Series 300 materials showed no sign of corrosion, nor adverse effect on adjacent 55% Al-Zn alloy-coated sheet panels. In all cases, the 400 Series and plated carbon steel materials did show signs of corrosion to varying degrees and would require replacement at some point prior to expiry of panels and sealants. There was no evident adverse effect on adjacent 55% Al-Zn alloy-coated sheet panels. Such replacement is economically feasible and the costs are computed within each site report (appendix).

(a) 300 series SS at 31 years

(b) 400 series SS at 31 years

(c) 300 series SS cap screws at 31 years

(d) Plated carbon steel at 31 years

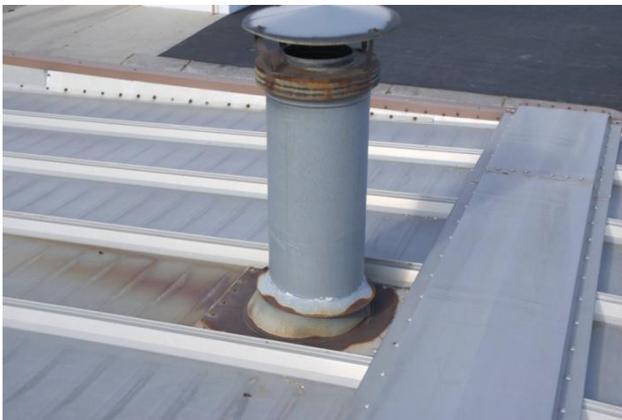
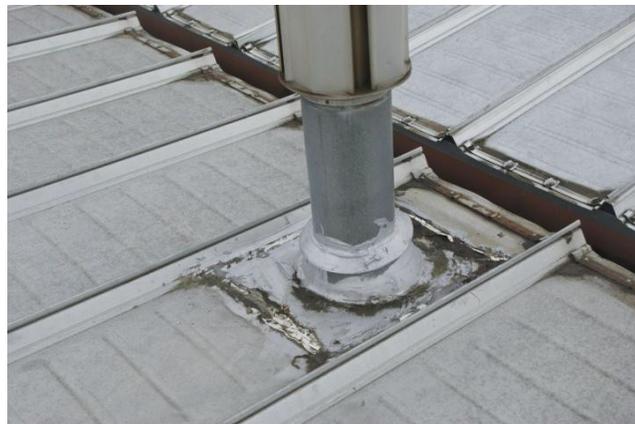
Round penetrations were primarily exhaust flues from space heating equipment within, or soil stacks related to plumbing mechanicals. In many cases, these flashings had been replaced with more appropriate flexible rubber flashings that currently reflect best practice. In other cases they had been coated and refurbished with liquid-applied coatings and external sealants. When these treatments had been executed there were often detrimental effects to adjacent roof panels. Best practice today utilizes methods shown in Figure 2, and these practices have been well-known and utilized in the trade for about 25 years. Several examples of improper (but typical to the era) round penetration flashings

Figure 19 – Two examples of flashing round penetrations

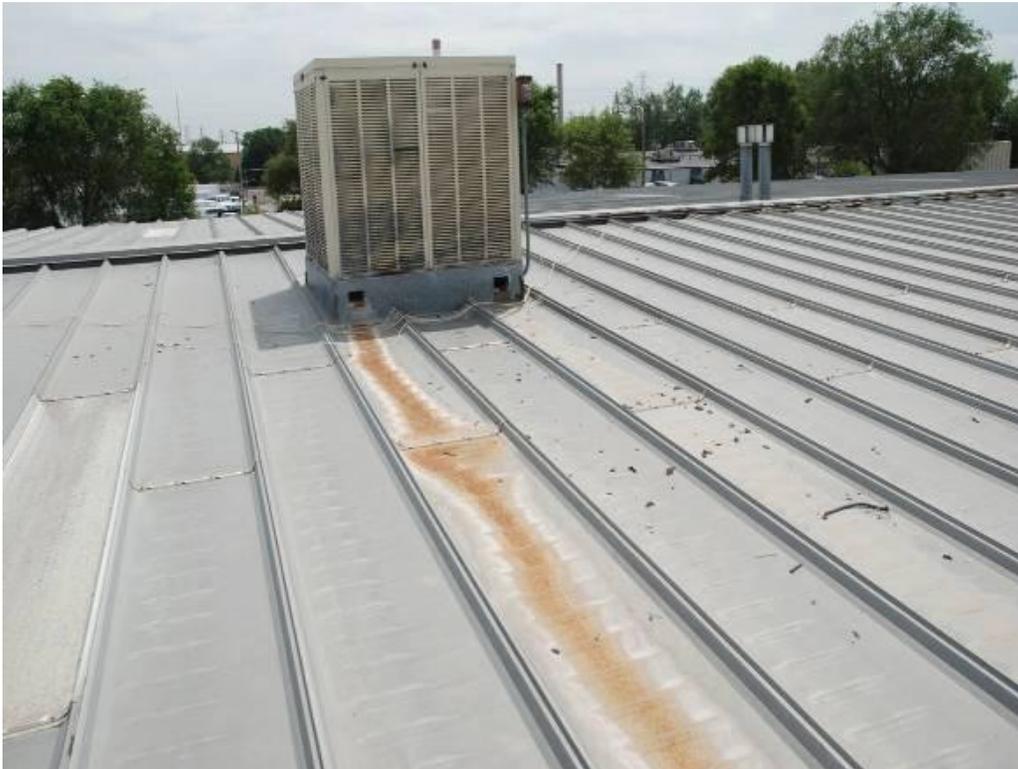
Mounting of air conditioning equipment and swamp coolers also reflected the common practices of the day 30+ years ago. Drainage of the effluent (copper-ion containing condensate) resulting from normal operation of condensing units was typically drained directly onto the roof surface, causing extensive corrosive effect to the exposed roof panels, as shown in Figures 20 and 21(right). These detrimental effects are well known by the trade today as is the solution prescribed earlier in this report under Best Practices.

Figure 20 – Accelerated corrosion of 55% Al/Zn sheet due to improper drainage of copper ion-containing HVAC condensate.

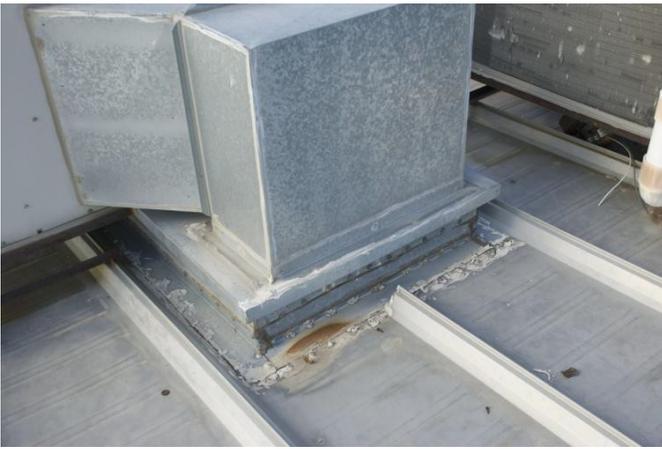
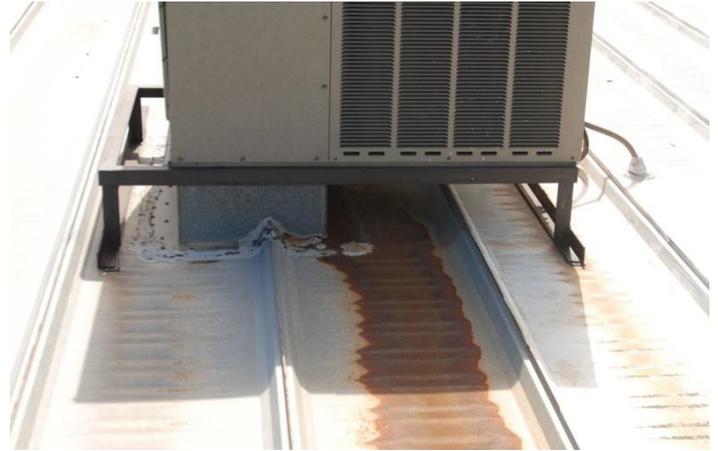
A variety of load-bearing and non-load bearing curb and flashing types were found still in place for the mounting of rooftop HVAC equipment, many exhibiting the common practices of the 1980's. In many cases these curb types were galvanized materials that have been treated with various topical sealants and coatings to restore weather integrity and prevent corrosion. Often units were mounted onto wood blocking which is corrosive to the roof material. Typical examples of poor HVAC mounting are shown in Figure 21. Best practices currently obviate the use of such materials.

Figure 21 – Typical examples of poor HVAC mounting

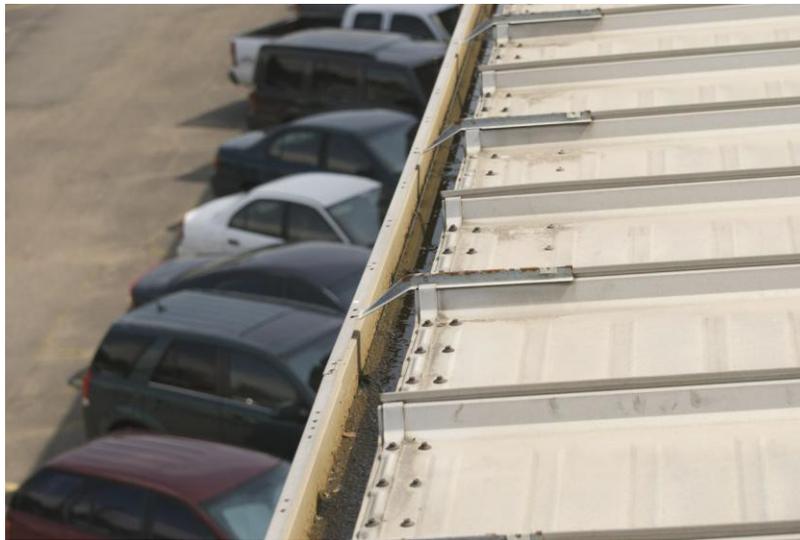
Gutters found at all sites were original material and were generally broken shapes of pre-painted G-90 steel, a typical example of which is shown in figure 22.

Figure 22 – Typical gutter manufactured from pre-painted galvanized G-90 steel.

In most cases, gutters will have to be replaced prior to end-of-life for the roof system. Remaining life and replacement costs of gutters are included in individual site reports. Gutters can be rather easily and economically replaced when necessary, and in no case would they effect end of life of the system.

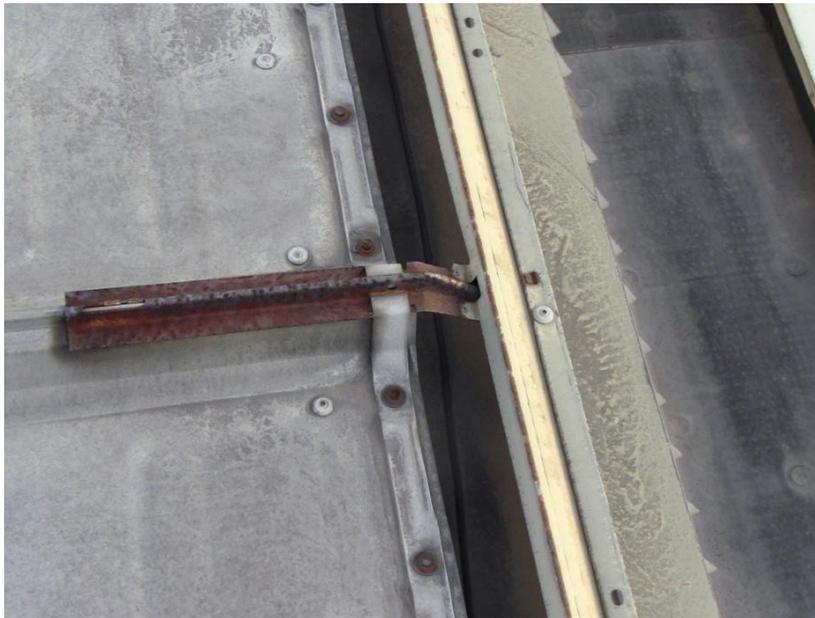
Figure 23 – Gutter hanger performance of galvanized G-90 steel after 32 years in Ohio.
