WHITE PAPER

Service Life Assessment of Low-Slope Unpainted 55%Al-Zn Alloy-Coated Steel Standing Seam Metal Roof Systems

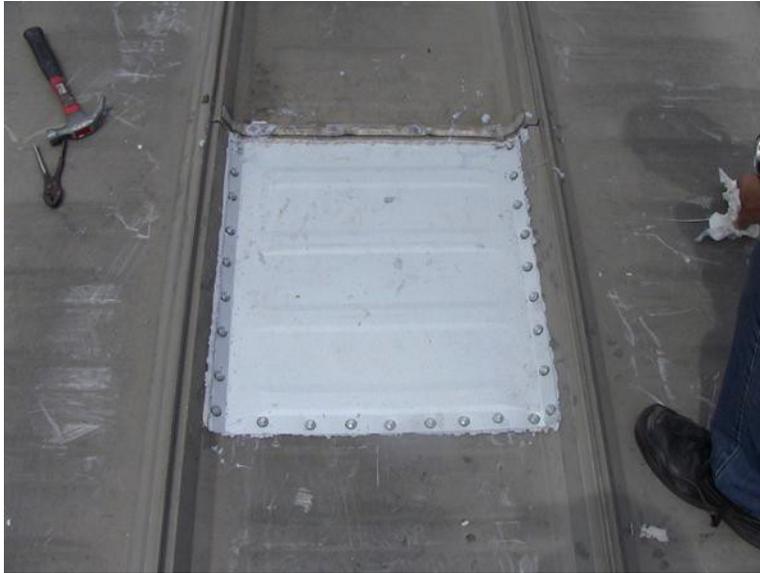
Figure 9 – Completed patch after removal of exposed sample.

Following the extraction of the specimen, field patching needs to be skillfully accomplished with new 55% Al-Zn alloy-coated material and sealed with butyl polymer tape. Figure 9 shows the specimen area from an actual site after the sample extractions and field patching of the area were accomplished.

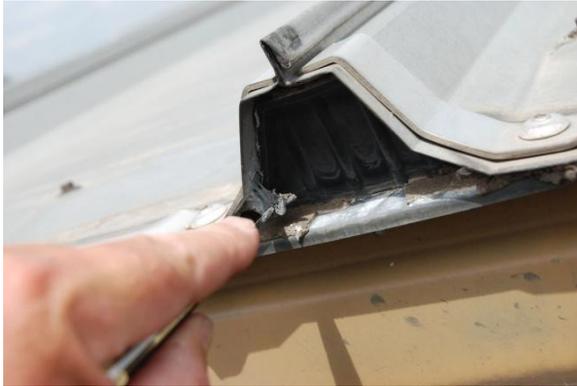
Although some of these materials were somewhat less durable than the panel material, they are used in areas where they are at least partially sheltered from U.V. and the most severe atmospheric weathering. The possible exception to this was when closures were used at the gutter line to seal between roof panel and back leg of gutter profile. In that location, closures are exposed to increased U.V. and although none had expired at the time of inspection, some (non-metal) closures showed some early stages of degradation on older specimen roofs. In such cases, the closure is not an eave closure, but a gutter closure, and not vital to building envelope integrity

Figure 16 – Typical eave closure.

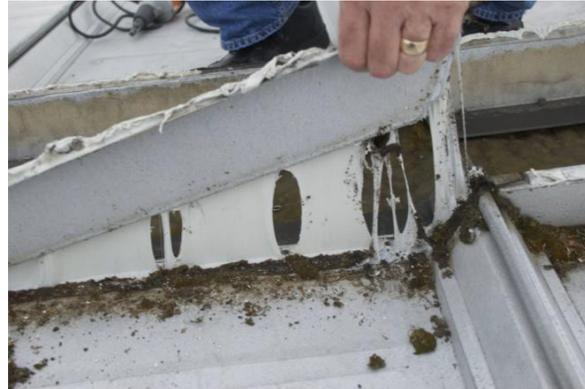
Figure 17 – Typical ridge closure.

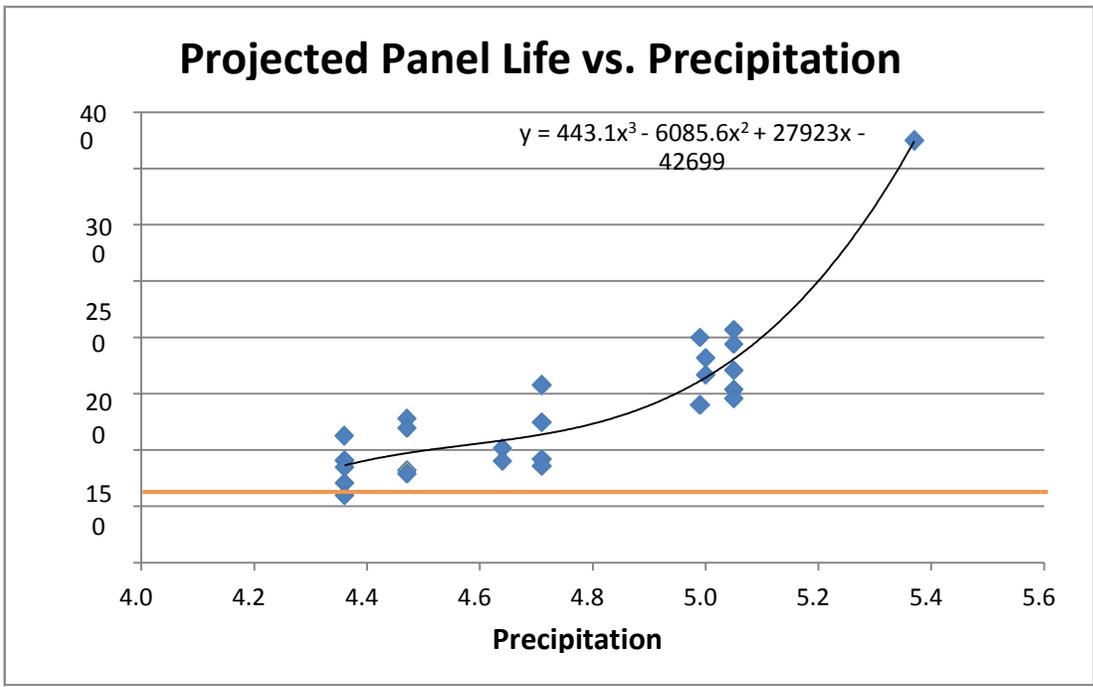
Using the calculated corrosion rates from Table II, the projected 55% Al-Zn alloy-coated steel panel service life is plotted in Figure 24 as a function of the precipitation pH associated with each building's location. It should be remembered here that the definition for panel service life was stated as the time required for total coating mass loss to occur due to corrosion of the top coating surface. Thus, it is a conservative definition because it does not include the additional years required, after the coating has been totally consumed, for the exposed steel substrate to corrode to a significant loss of thickness that would define a more accurate end of roof service life.

As seen in Figure 24, there is a very good correlation between the precipitation pH and the projected 55% Al-Zn alloy-coated steel panel service life, a finding which helps to explain the wide range of service life values calculated from the corrosion rates determined in this study. That is, the wide range in precipitation pH for the different building locations accounts for the wide range of projected service life values and is consistent with the expectation that more aggressive environments (lower pH) are more corrosive to materials of construction exposed to those atmospheric conditions.

Figure 24 – Strong correlation between projected service life for 55%Al-Zn alloy-coated steel SSR panels and precipitation pH.

The reference line at 60 years in Figure 24 is significant in that it represents an “assumed building service life” as described in LEED, version 4 [22]. Thus the data from this project support the proposition that a 55% Al-Zn alloy-coated steel SSR system, installed today on new or retrofit low-slope roof systems in a wide range of environments, would not require replacement during the building’s entire service life, a significant advantage compared to other roof systems that require one or more full replacements within this 60-year period. Periodic roof inspections and maintenance associated with roof ancillaries are advised, to minimize any detrimental effects to the roof system and maximize roof system life.

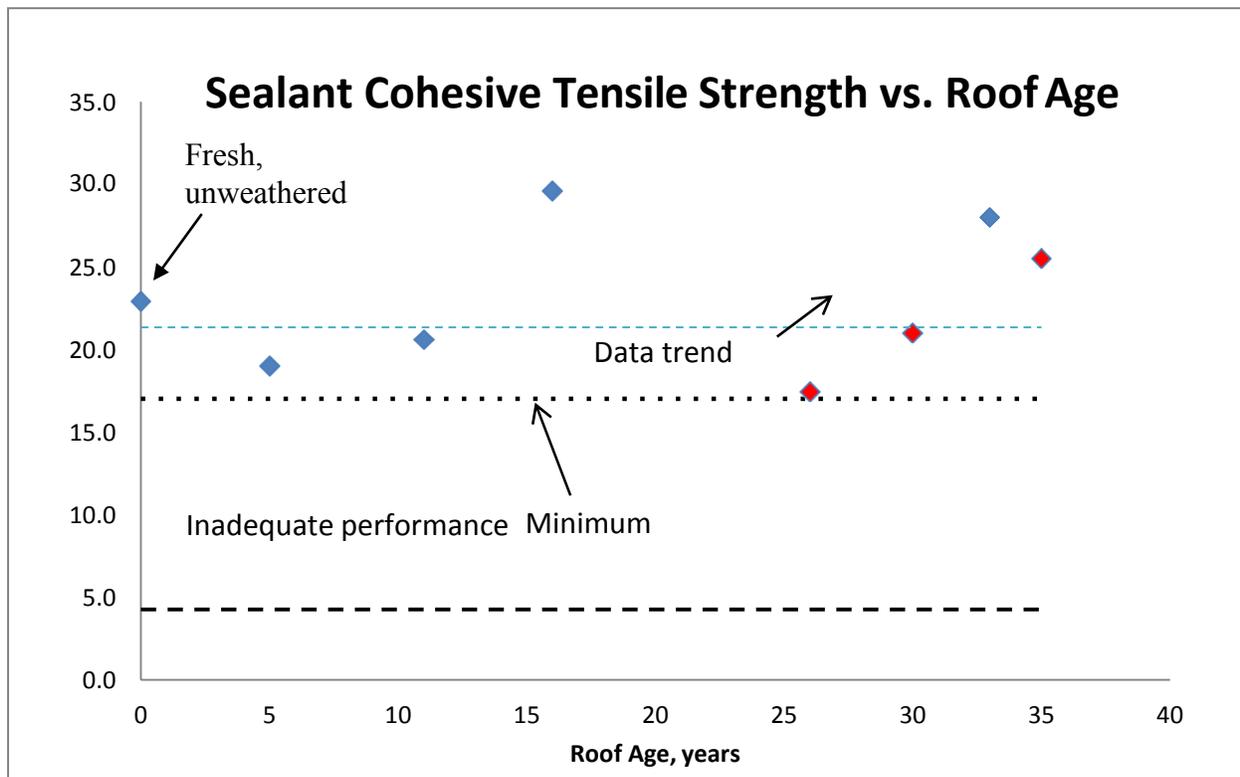
Cohesive tensile strength can be thought of as a measure of the ability of a sealant to maintain internal integrity and resist shearing in order to effectively seal the joint. The cohesive tensile strength of the butyl sealant samples obtained in this study is plotted as a function of the age of the roof in Figure 26. The inadequate performance value was assumed to be at $\frac{1}{4}$ of the minimum specification limit of 17 psi, or at 4.25 psi, and is plotted as such. At this low level of cohesive tensile strength, it was speculated that the sealant would have undergone significant decomposition, or de-polymerization, with the result being that the sealant would behave more like a low-viscosity liquid that would easily flow out of the joint, thus rendering the joint unacceptable.

The plot in Figure 26 shows that, even for those sealant samples exhibiting some degree of de-polymerization, the cohesive tensile strength continues to maintain consistent levels above the minimum specification and well above the inadequate performance level. Based on the data in Figure 26, there is no evidence of deterioration of this property through 35 years of service on these roofs

Figure 26 – Cohesive tensile strength of butyl sealant vs. roof age. Sealant samples from New England roofs. Red symbols indicate samples exhibited some degree of de-polymerization

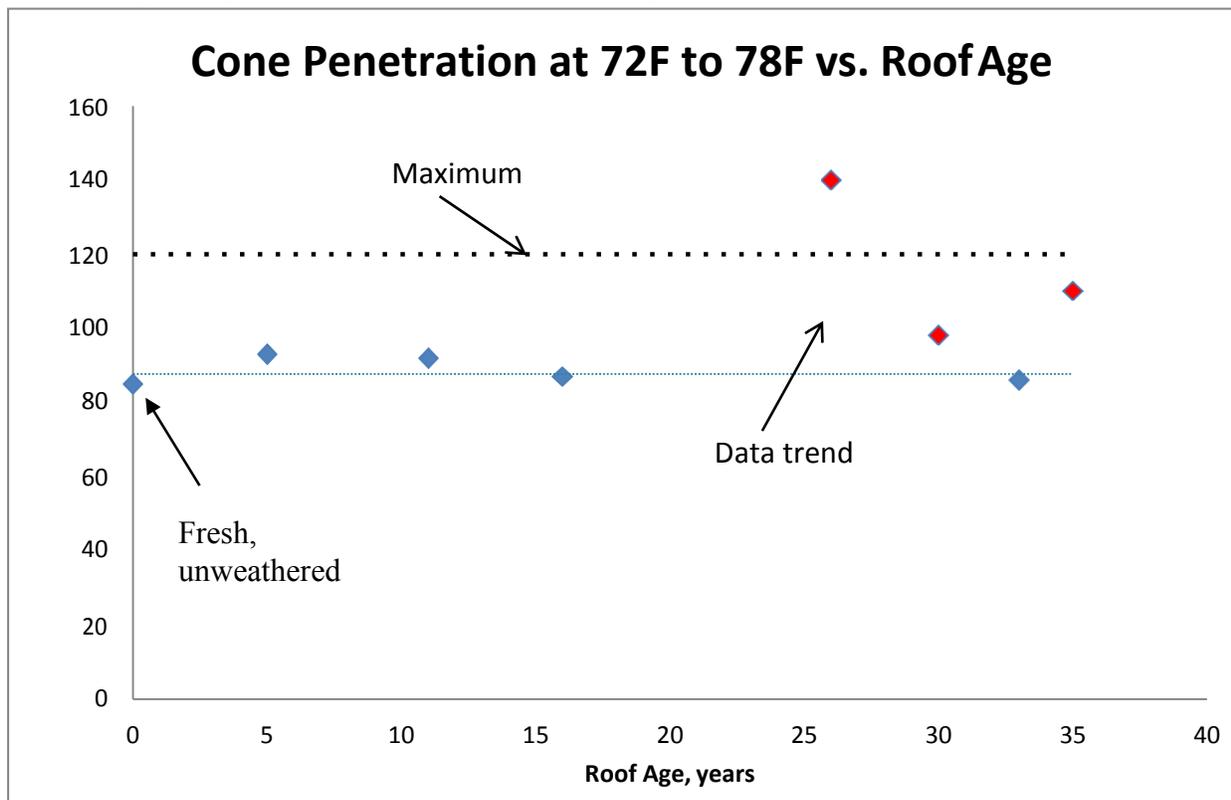
The cone penetration data are plotted vs. roof age in Figure 27. Higher cone penetration values indicate the sealant exhibits an increased tendency to flow. The maximum specification at 120 is a value selected for qualifying butyl sealants for initial use. All but one of the data points are under this maximum value. The sealant samples from the 26-, 30- and 35-year roofs, noted with red symbols, showed evidence in laboratory analysis of some degree of de-polymerization. This condition was noted in the cone penetration testing done at 120F in which the materials exhibited a level of softness that prevented valid test results from being obtained. Notwithstanding these laboratory observations, the behavior of these sealants in the actual roof systems was judged to be entirely adequate and without issue, providing a weather tight seal.

The cone penetration data trend line in Figure 27 shows a slight upward trend toward the maximum specification line and would mathematically intersect that line at approximately 57 years. However, the amount of scatter in this limited data set is significant (correlation coefficient less than 0.20), so it is unwise to draw a firm conclusion from such an intersection. However, it is also unclear whether a cone penetration value of 120 is indicative of inadequate performance. What is clear, is that the 26-, 30- and 35-year roofs in New England continue to perform well, and that the roofs in AZ, NM and CO exhibit excellent cone penetration values, and field performance, after up to 33 years (Table III). Thus, the likelihood of butyl sealants achieving a failure mode prior to about 60 years of service is deemed to be nil.

Figure 27 – Cone penetration values of butyl sealant vs. roof age. Sealant samples from New England roofs. Red symbols indicate samples exhibited some degree of de-polymerization.
